Technical Preservation Services National Center for Cultural Resources

The Secretary of the Interior's Standards for Rehabilitation

Subject: Deteriorated Plaster Finishes

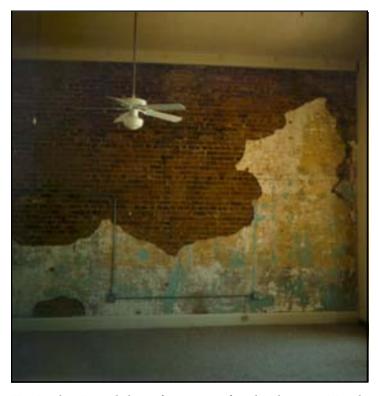
Keeping deteriorated plaster fragments as found without repairing the plaster finish is not an appropriate rehabilitation treatment for most historic building interiors.
